GIKEN LTD. Kochi Head Office Car Parking

Location : Kochi-shi, Kochi

Completion : August 2018

Renovation works completed at head office ECO Park

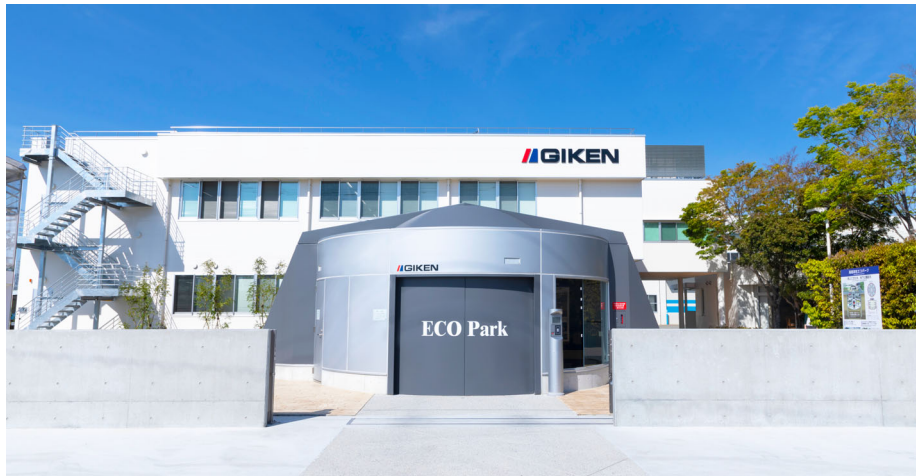
The first ECO Park was constructed in 1994 at Giken's Kochi office. Despite experiencing the strong earthquakes in 1995 (Hanshin-Awaji) and 2001 (Geiyo), the ECO Park withstood the seismic events and there was no damage to the underground structure. To meet the needs and trends of a changing automotive industry, the ECO Park has recently undergone renovation works. Retaining the main underground structure, the systems and mechanical components were refitted with the latest ECO Park designs. One example is the two-sided sliding doors which reduces the entry / exit opening to the minimum.

With an upgraded control system, this latest ECO Park model vastly reduces the average retrieval time to 29 seconds, which is 9 seconds faster than the models previously installed.

The installation embodies Giken's concept of "Cultural Aboveground and Function Underground"
